FINAL
**Sediment Monitoring
Summary Report
2007 Remedial Dredging**

**New Bedford Harbor Superfund Site
New Bedford Harbor, MA**

**Sediment Monitoring Summary Report
2007 Remedial Dredging**

**Battelle
397 Washington Street
Duxbury, MA 02332
(781) 934-0571**

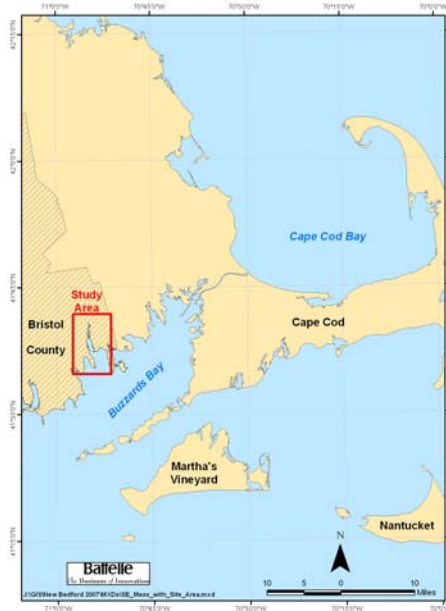
Figure 1. Location of the Site in Southeastern, MA.

The New Bedford Harbor Superfund Site (Site), located in Bristol County, Massachusetts (MA), extends from the shallow northern reaches of the Acushnet River estuary south through the commercial harbor of New Bedford and into 17,000 adjacent acres of Buzzards Bay (Figure 1). Industrial and urban development surrounding the harbor has resulted in sediments becoming contaminated with high concentrations of many pollutants, notably polychlorinated biphenyls (PCBs) and heavy metals. Two manufacturers in the area used PCBs while producing electronic devices from the 1940s to the late 1970s, when the use of PCBs was banned by the U.S. Environmental Protection Agency (USEPA). Based on human health concerns and ecological risk assessments, USEPA added New Bedford Harbor to the National Priorities List in 1983 as a designated Superfund Site. Through an Interagency Agreement between the USEPA and the U.S. Army Corps of Engineers, New England District (USACE NAE), the USACE is responsible for carrying out the design and implementation of the remedial measures at the Site. The Site has been divided into three areas – the upper, lower and outer harbors – consistent with geographical features of the area and gradients of contamination (Figure 2).

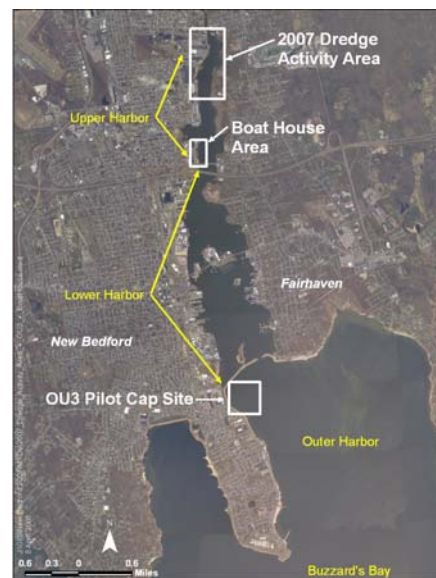
Figure 2. Location of the 2007 Dredge Activity Area within New Bedford Harbor

Aerovox Inc. located in New Bedford, MA used PCBs in the manufacture of electrical capacitors from approximately 1940 to 1977. This facility is located in the upper harbor and is considered one of the major sources of historic PCB contamination to New Bedford Harbor. The highest concentrations of PCBs were found in sediments in a 5-acre area in the northern portion of the Acushnet River Estuary adjacent to the Aerovox facility. These ‘hot spot’ sediments, which contained PCBs upwards of 100,000 milligrams per kilogram (mg/kg), were removed between 1994 and 1995 as part of USEPA’s 1990 “Hot Spot” Record of Decision (ROD). Full scale remediation dredging per the 1998 Upper and Lower Harbor ROD was initiated in 2004 and continued in 2005, 2006, and 2007. Another known source of PCB contamination in New Bedford Harbor is related to activities at the Cornell-Dubilier mill on the western shore of the outer harbor. In 2005, a 15 acre underwater cap pilot project was implemented near Cornell-Dubilier to cap PCB-contaminated sediments (Figure 2).

The OU3 Pilot Cap site is a localized area of elevated PCB concentrations located outside the hurricane barrier in New Bedford, MA (Figure 2). In 2005 the OU3 Pilot Cap site was capped with parent material dredged during the construction of a navigational dredged material Confined Aquatic Disposal (CAD) cell in New Bedford Harbor. Annual monitoring has been conducted since 2005 to assess temporal trends in PCBs in surficial sediments and the effectiveness of the cap.

OU3 Pilot Cap — Grab sampling was conducted at 17 sample locations at the OU3 Pilot Cap site (Figure 2) to collect surficial sediments for PCB analysis. A 0.04m² modified Van Veen grab was used to collect sediment samples. Sample locations were based on stations previously visited by ENSR/AECom on August 25, 2005, shortly after the completion of capping activities (ENSR, 2006). Bathymetric data collected just after the capping event revealed a series of ridges and valleys formed by placement of cap materials along an east-west axis. At the time of the 2005 bathymetry and sampling as much as a 4-foot difference in elevation existed amongst the topography at this site. The 2005 sediment sampling locations were positioned to achieve good spatial coverage over the site and to obtain data representative of the high and low spots existing in the sediment cap at that time.

The OU3 Pilot Cap site is a localized area of elevated PCB concentrations located outside the hurricane barrier in New Bedford, MA (Figure 2). In 2005 this area was capped with parent material dredged during the construction of a CAD cell in New Bedford Harbor. Annual monitoring has been performed since 2005 (shortly after completion of the capping activity) to determine the effectiveness of cap placement in lowering surficial sediment PCB concentrations, as well as the extent of change in PCB concentrations over time.

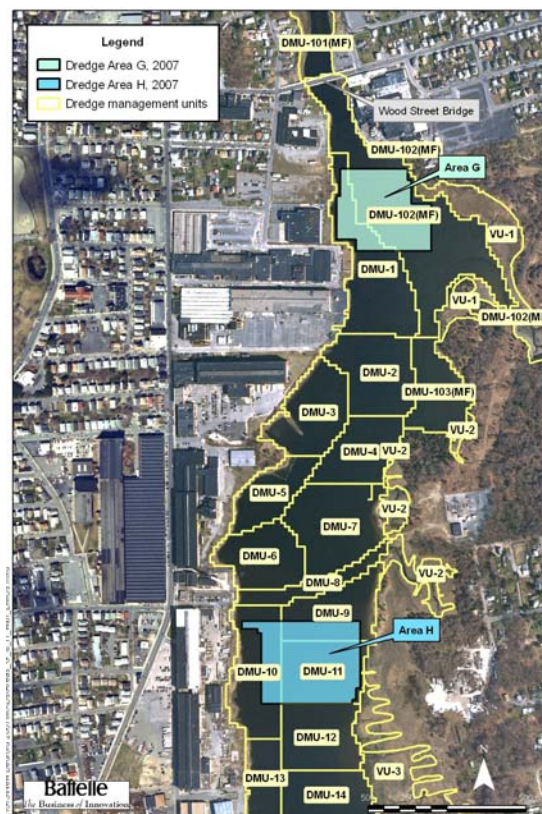
Figure 3. 2007 Dredge Areas.

The Site is divided into a series of Dredge Management Units (DMU) based on contamination levels, contamination sources, topography, and other factors. In 2007, dredge activities were conducted at two areas: ‘Area G’ encompassing sections of DMU-1 and DMU-102 and ‘Area H’ encompassing sections of DMU-9 and DMU-10, and DMU-11 (Figure 3).

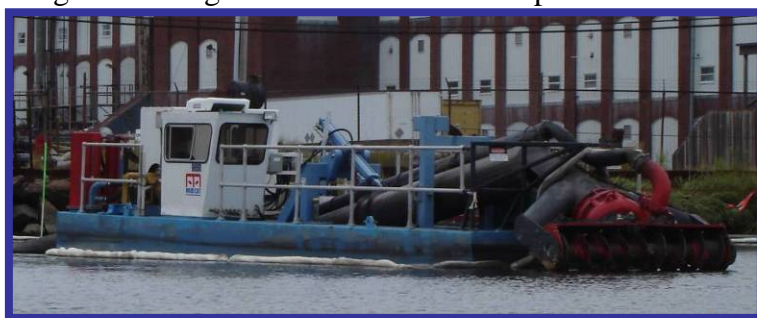
Figure 9. Mud CatTM Hydraulic Dredge.

Dredging was performed using a Mud CatTM hydraulic dredge equipped with a horizontal auger (Figure 9). The dredge was propelled by winching itself along a traverse cable which spans the dredge area to opposite sides of the perimeter cable. As a pass was completed, support crews relocated the cable to position for the next pass. The auger on the dredge is eight-ft wide. Six foot wide dredge passes were conducted. This provided two feet of overlap into the previous pass to capture any residual sediment which may have sloughed into the new cut. Dredge material was pumped through a pipeline to a booster pump, then to the desanding facility at Sawyer Street. Following desanding, the remaining fine material was pumped via a separate pipeline to the dewatering, treatment, and handling facility in the Lower Harbor. In total, the 2007 dredging removed over 23,300 cubic yards of material (Jacobs, 2008).

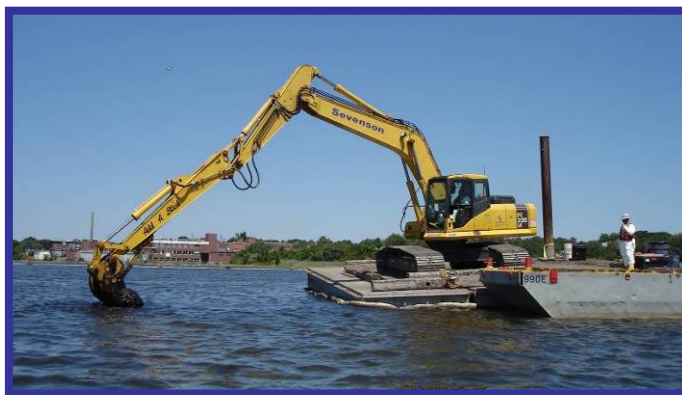
Figure 10. Debris Removal Excavator.

The hydraulic dredge can not handle large debris which is common in this portion of the harbor. Debris removal was accomplished by ‘raking’ the bottom with a barge-mounted excavator

(Figure 10). Barges secured to the side of the debris removal platform stored the debris and were moved offsite as needed. Support boats were used throughout the operation to transport crews, maintain dredges, handle the pipeline, and move barges.
